THE NAVAL AVIATION SAFETY REVIEW

JANUARY 1962

Approach to Minimums?

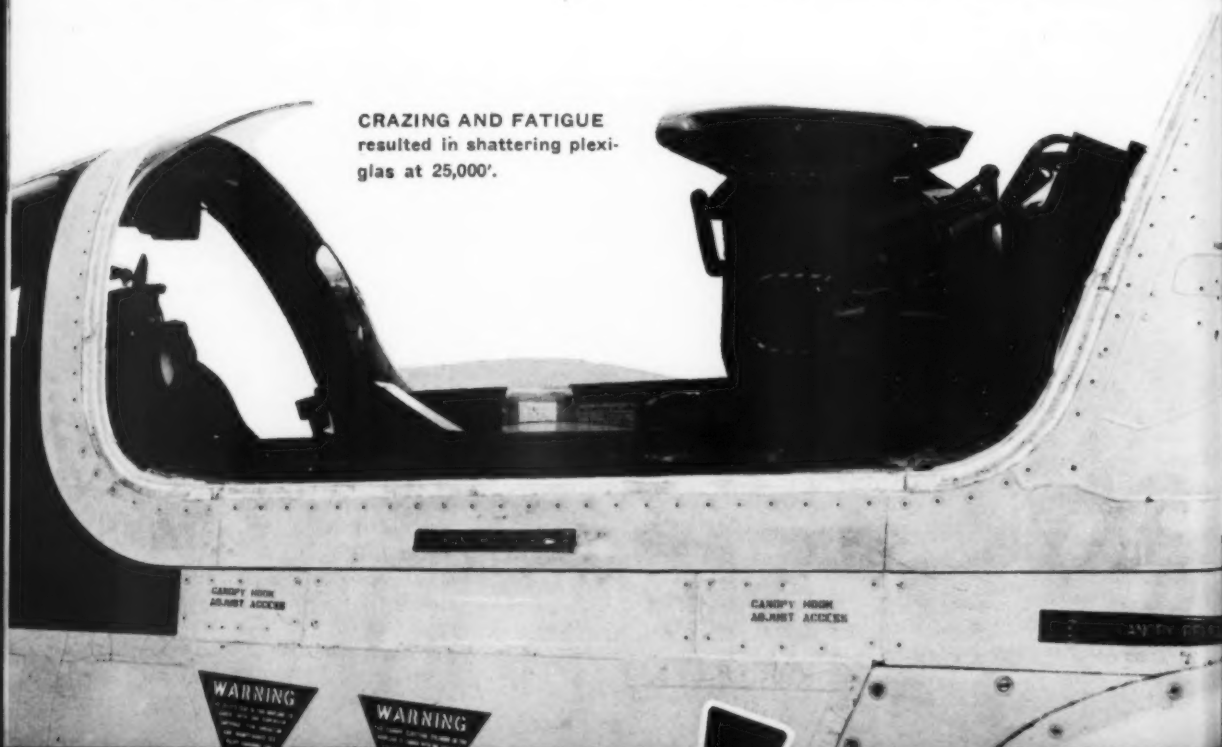
CRAZING AND FATIGUE
resulted in shattering plexi-
glas at 25,000'.

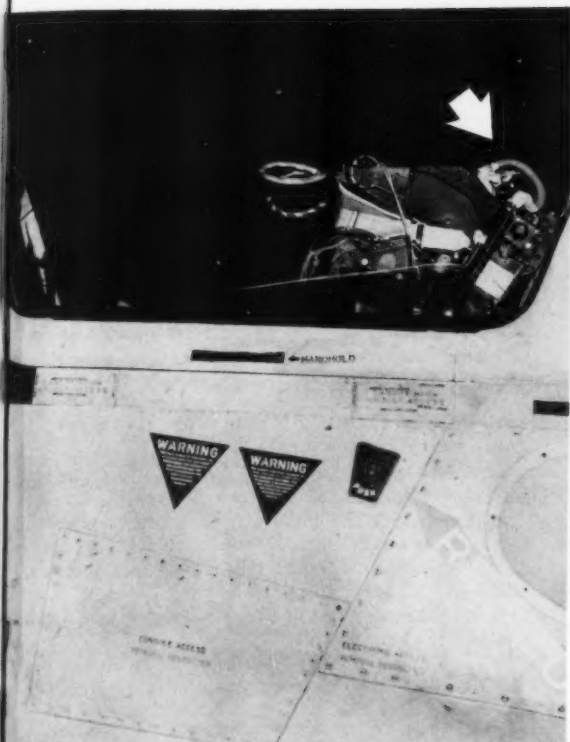
MARTIN-BAKER equipped F8U experienced plexiglas implosion at 23,000'. Improper packing of drogue chute can cause misalignment of drogue scissors (indicated by arrow) and canopy interference.

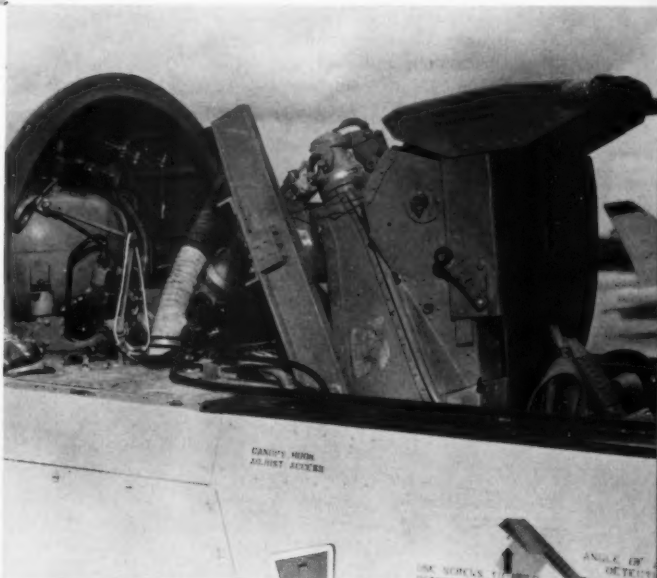
PLEXIGLAS FAILURE led to loss of entire F8U canopy—note caution to position headrest for canopy clearance.

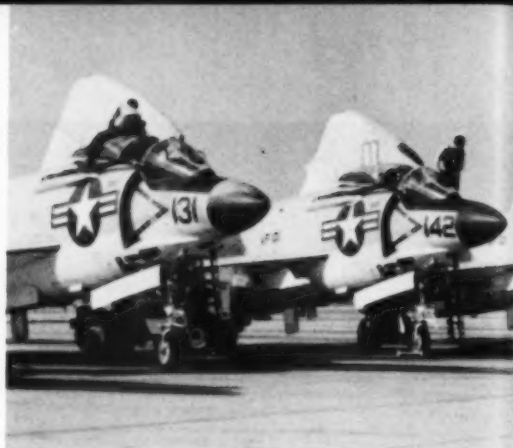
CANOPY CARE can prevent bubble trouble.

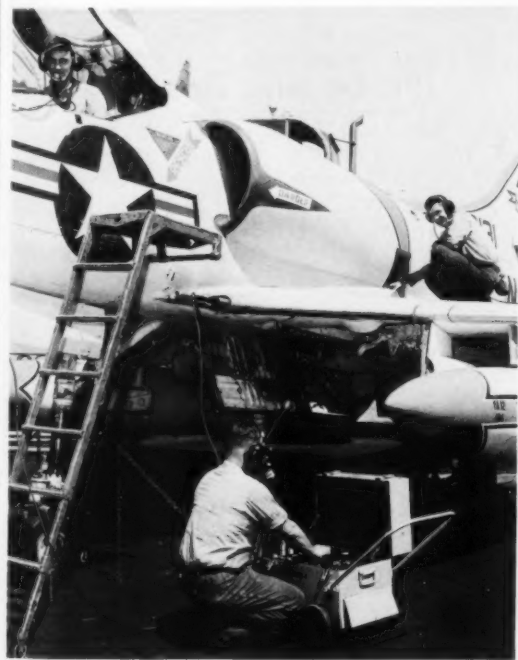
JET-CAL COMMUNICATIONS—VA-12 extends the use of sound power during jet-calibration by adding two outlets to the normal two-man rig allowing new mechanics to hear what's going on during the noisy operation. By splicing the communications cable or using a central jack, VA-12 now has an improved jet-cal capability that is safer and more effective, is an efficient training aid and provides improved quality control.—LT T. P. SCOTT, Safety Officer
